BRE Test Report

Impact resistance tests on Lapitec stone panel wall system

Prepared for: Stephen Pike
Date: 29 October 2014
Report Number: 295071 Issue: 1

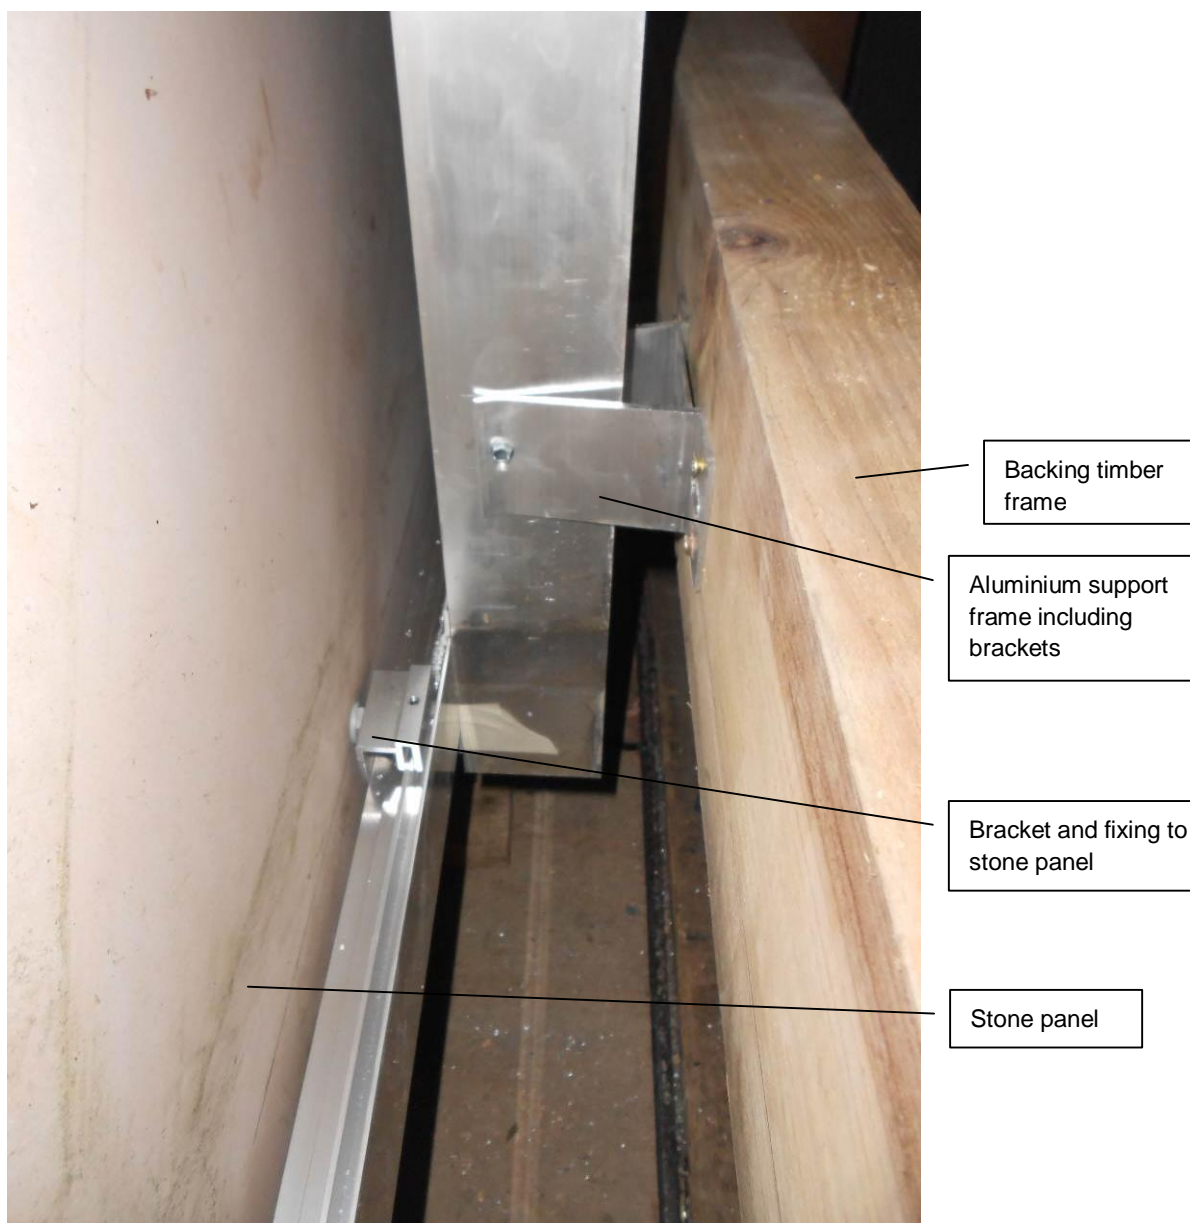
Figure 1. Lapitec stone panel wall system

The Granite and Marble Centre supplied new components and constructed test specimens onto BRE's test rig. Figures and drawings in the Annex to this report show the general test set up of the test specimen mounted on BRE's test rig.

- Type:** Lapitec stone panel wall system comprising an aluminium support frame mounted on a timber backing frame fixed to BRE's test rig.
- BRE test rig:** The BRE test rig comprises an adjustable steel frame with adjustable steel columns fixed to the laboratory's concrete floor.

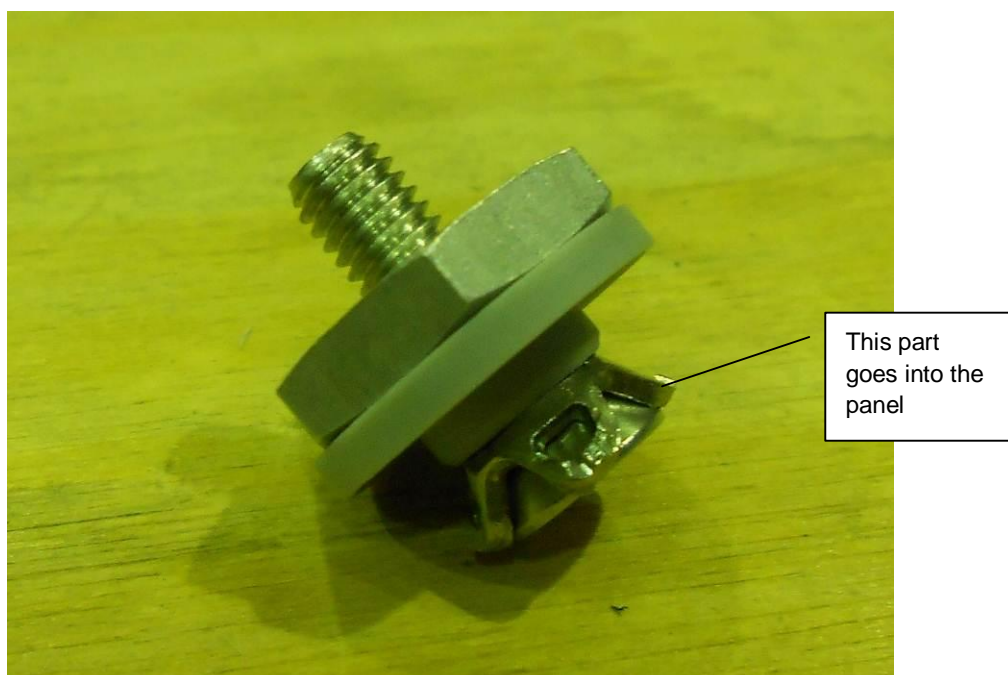
Figure 2. 12 mm thick panels are fixed with Fischer fixings FZPII 11 x 7 M6/T/9 AL with 7 mm engagement into four holes on the back of each panel.

- Stone panels:** Two thicknesses of the Lapitec stone panel wall system were tested; 12 mm thick panels and 20 mm thick stone panels.
- Fixings:** 12 mm thick panels are fixed with Fischer fixings FZPII 11 x 7 M6/T/9 AL with 7 mm engagement into four holes on the back of each panel.
20 mm thick panels are fixed with Fischer fixings FZPII 11 x 12/18 A4 into four holes on the back of each panel.

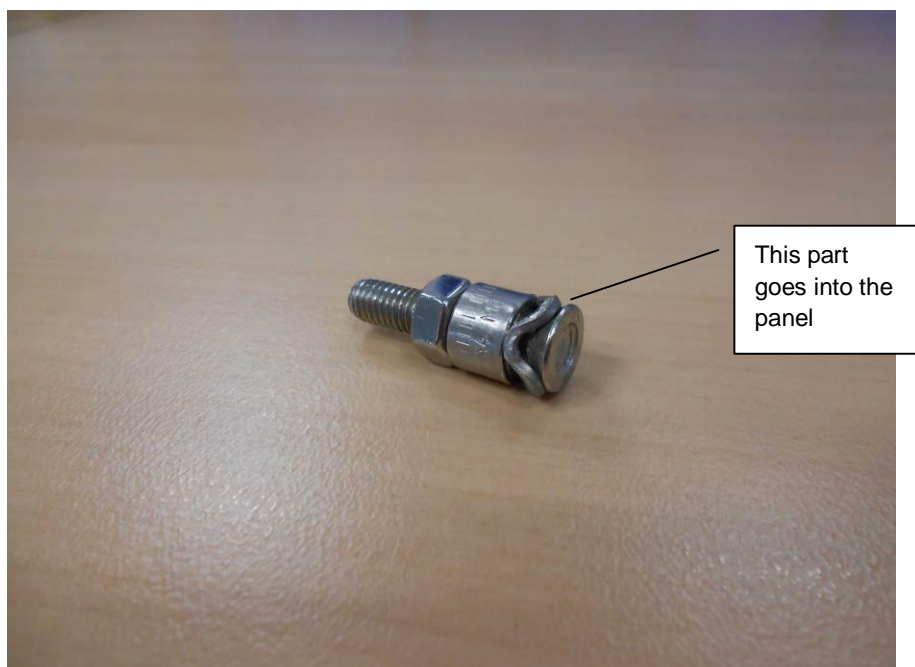
Figure 3. 20 mm thick panels are fixed with Fischer fixings FZPII 11 x 12/18 A4 into four holes on the back of each panel.

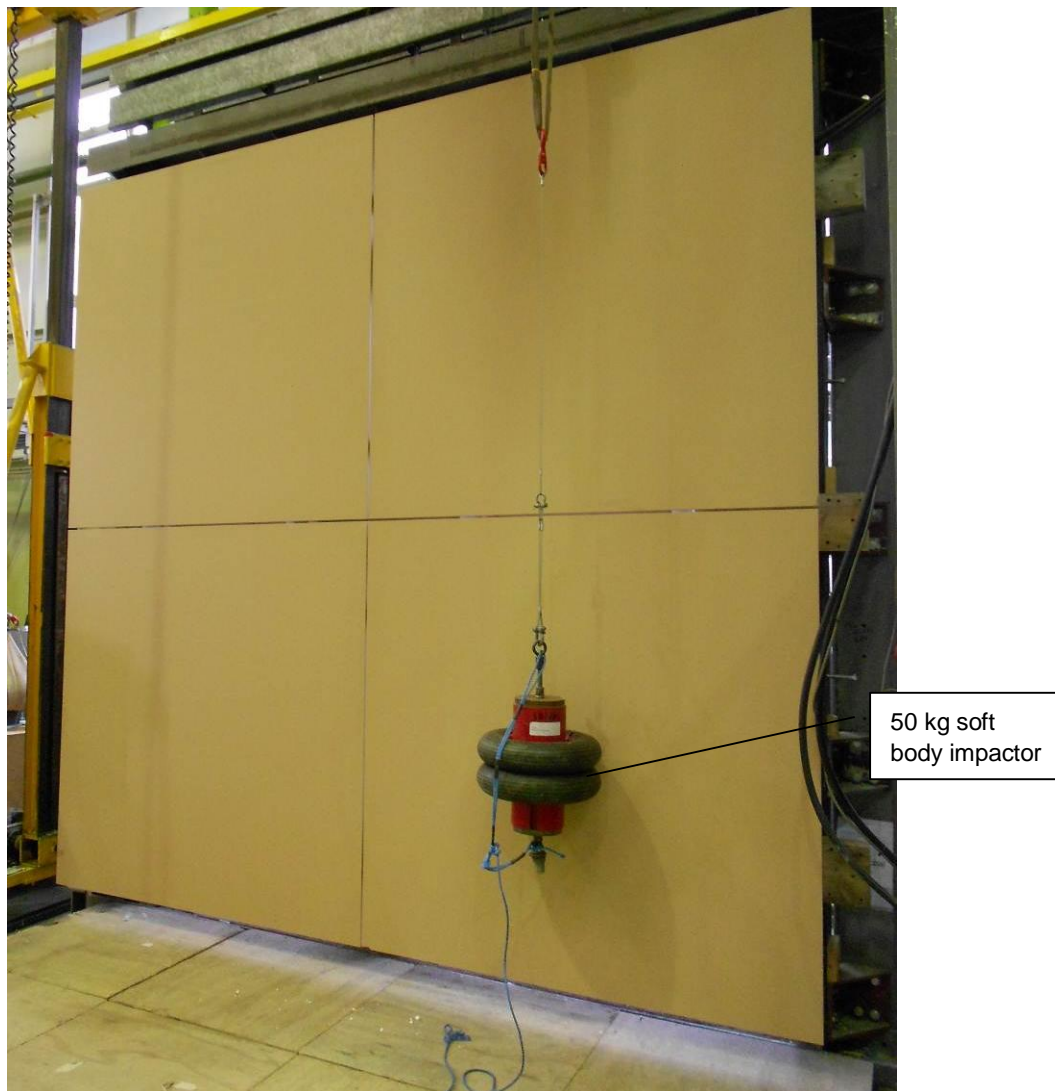
Figure 4. 12mm thick Lapitec stone panel wall system prior to first soft body impact test

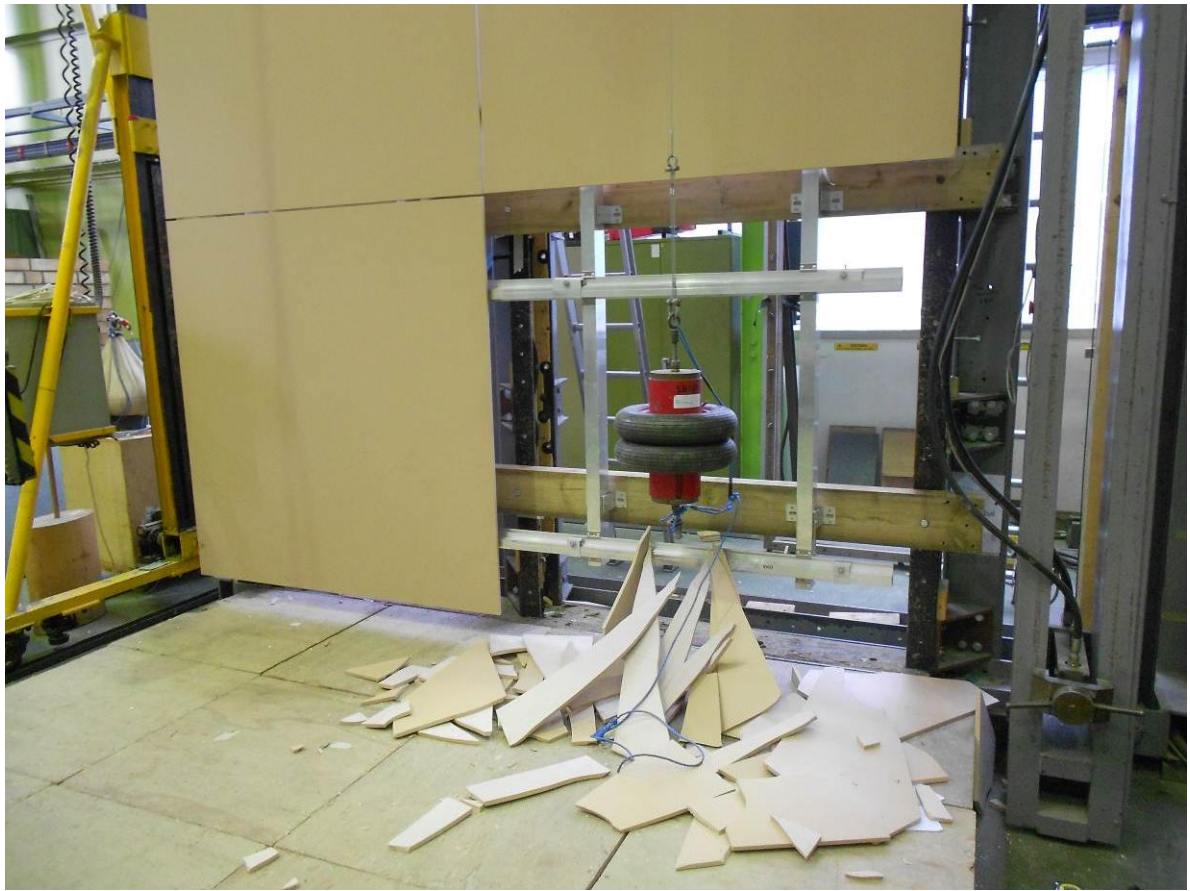
Figure 5. After a soft body impact on 12 mm thick panels – at 93.1 Nm

12 mm thick panels: When subjected to 93.1 Nm impact (190 mm drop height) at the centre of a panel, disintegration of the panel occurred on impact. When measured the largest crack free fragments do not conform to the test requirements of Clause 4a or b in BS EN 12600 (see Section 3 of this report, Assessment criteria).

The 12 mm thick Lapitec stone panel wall system does not achieve Class 3 of BS EN 12600. (Class 3 is the lowest drop height and impact energy class in that standard).

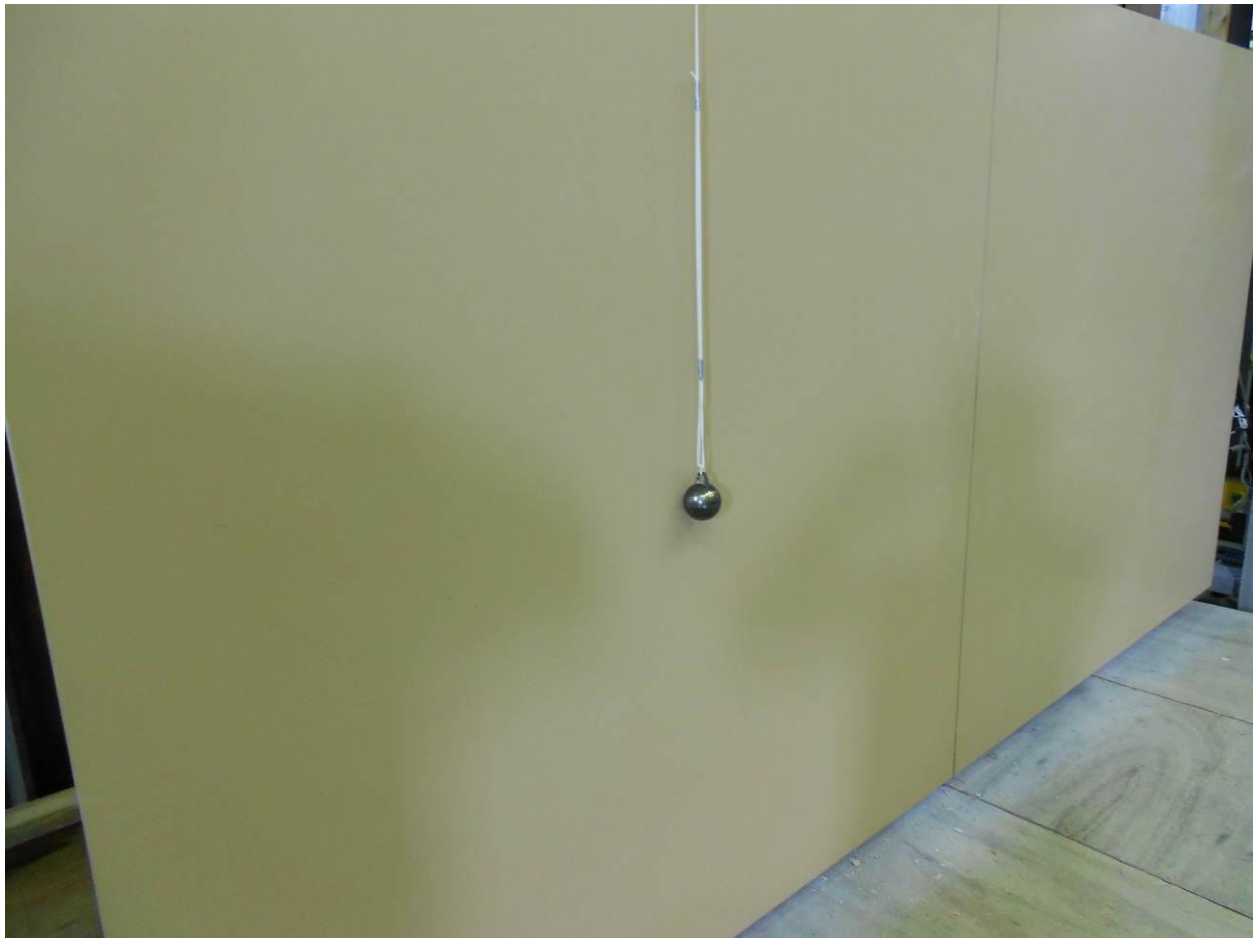
Figure 6. 12mm thick Lapitec stone panel wall system prior to first hard body impact test

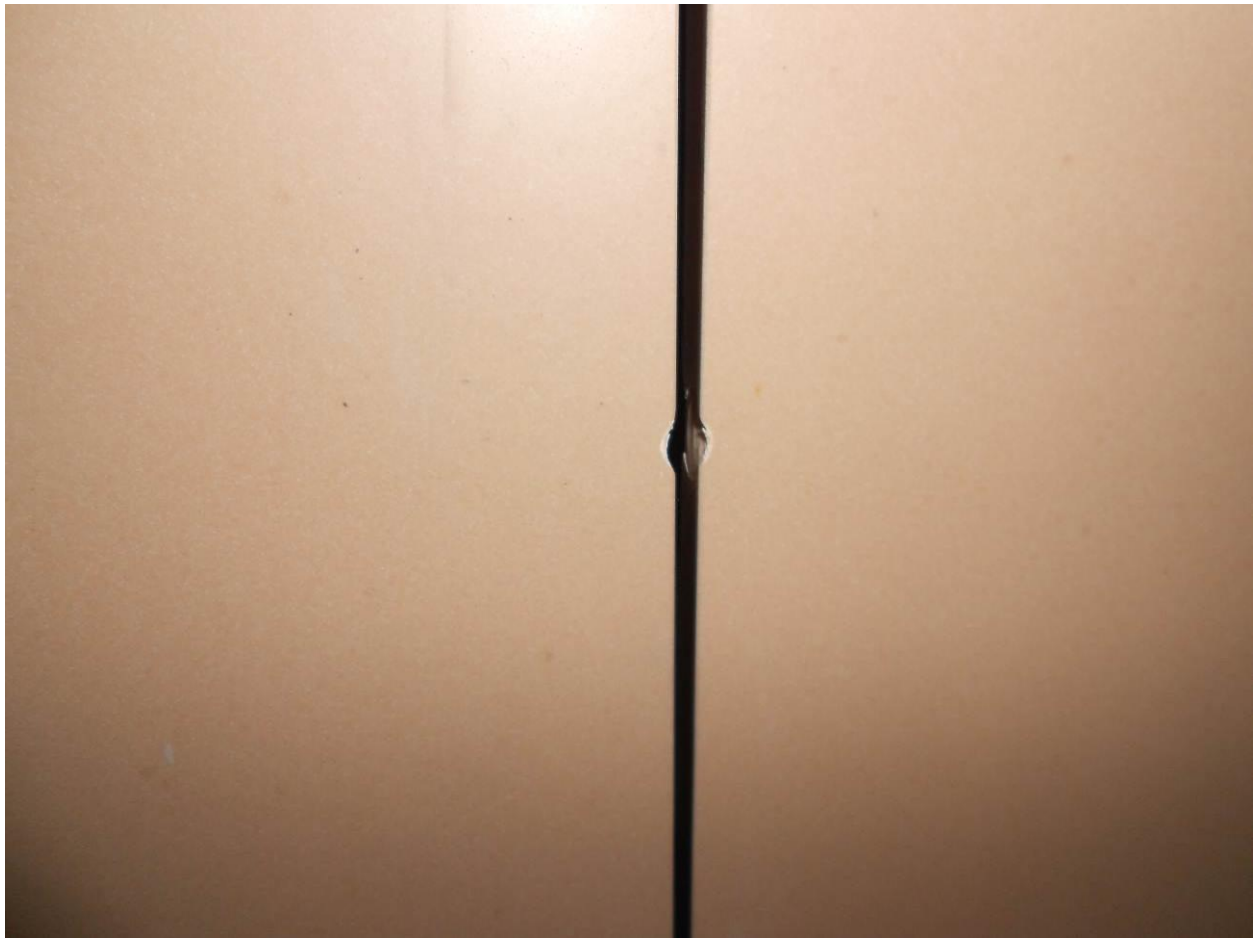
Figure 7. Typical damage after hard body impact on 12 mm thick panels – at joint with adjacent panel

12 mm thick panels: When subjected to 3.0 Nm impact near a corner of a panel a large section broke away on impact. In BS 8200, for brittle materials, the results of the impact tests are defined as either failure or no damage. (see Section 3 of this report, Assessment criteria).

The 12 mm thick Lapitec stone panel wall system failed when subjected to hard body impacts at the lowest impact energy (3 Nm) given in BS 8200 for retention of performance of exterior wall surfaces.

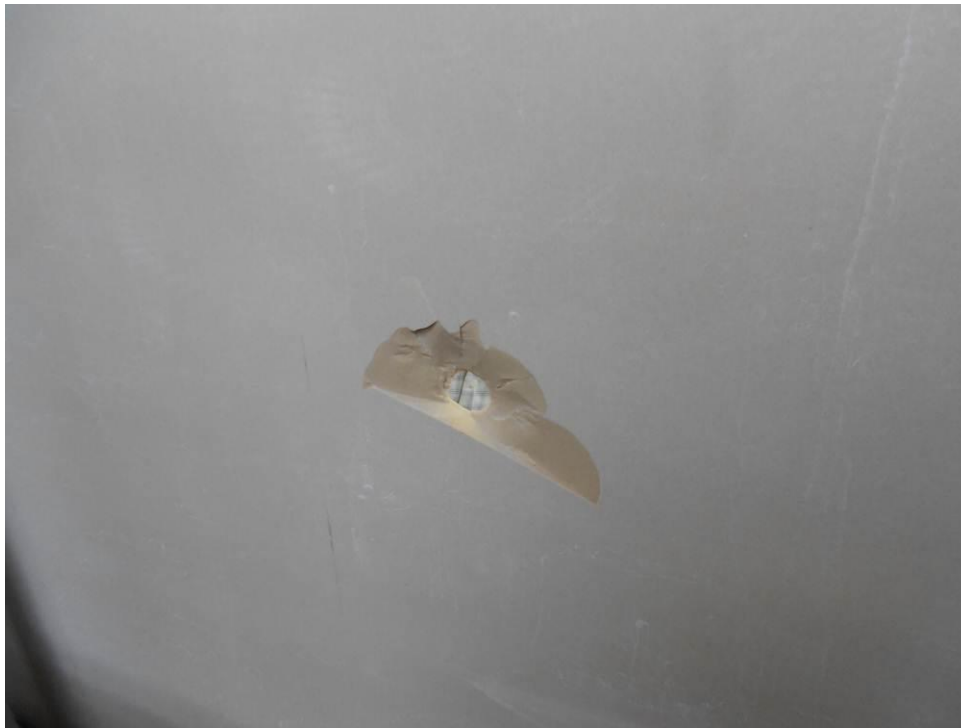
Figure 8. Typical damage after hard body impact on 12 mm thick panels – on the reverse side of the panel

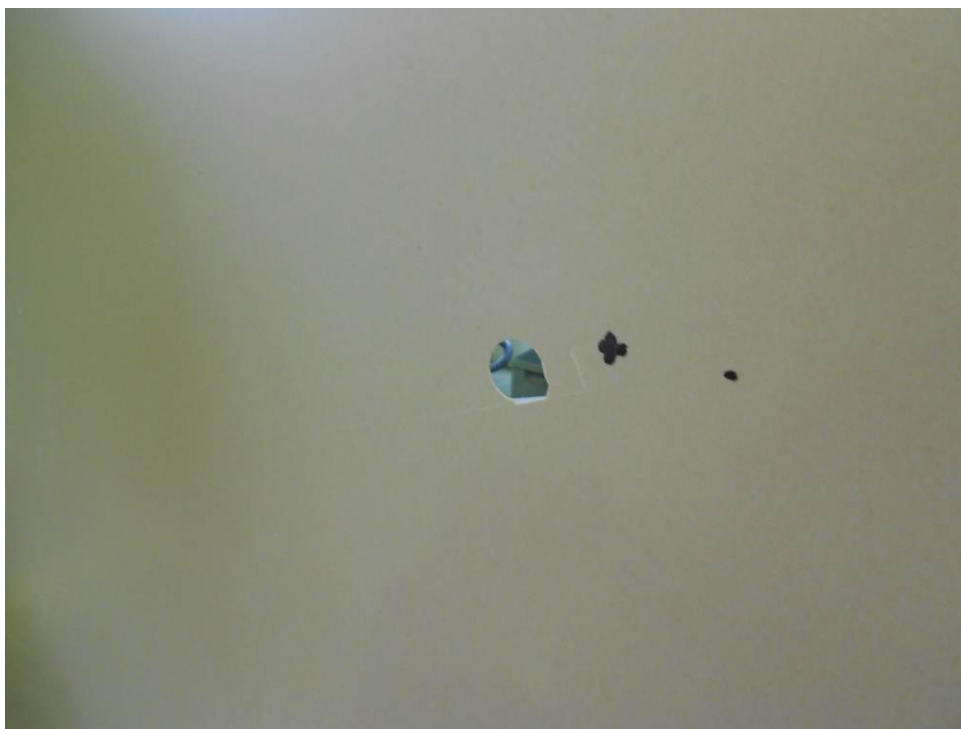
Figure 9. Typical damage after hard body impact on 12 mm thick panels – damage on the front face corresponding to Figure 8 above.

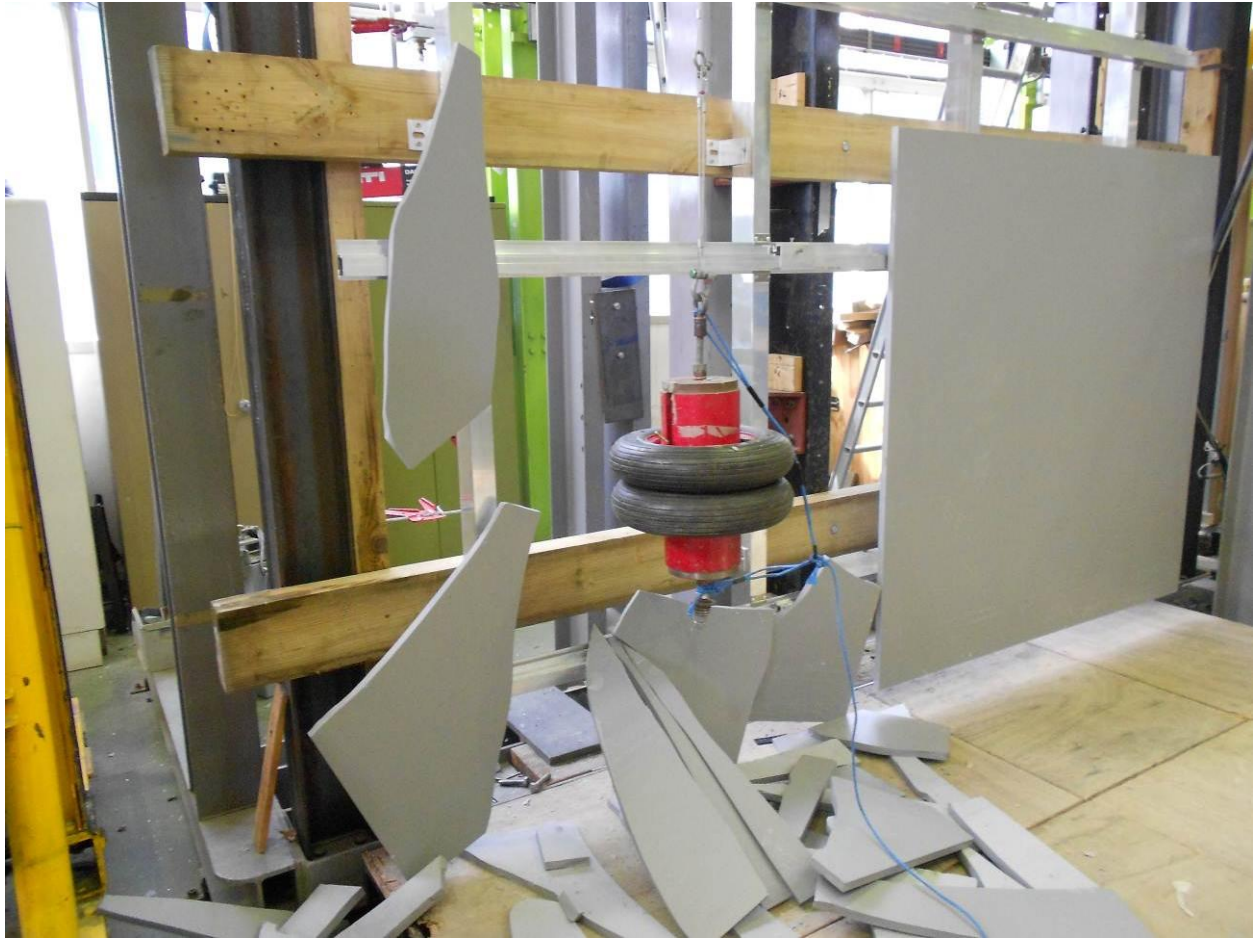
Figure 10. After a soft body impact on 20 mm thick panels – at 588 Nm

20 mm thick panels: When subjected to 588 Nm impact (1200 mm drop height) at the centre of a panel, disintegration of the panel occurred on impact. When measured the largest crack free fragments do not conform to the test requirements of Clause 4a or b in BS EN 12600 (see Section 3 of this report, Assessment criteria).

The 20 mm thick Lapitec stone panel wall system achieved Classes 2 and 3 of BS EN 12600 but failed at Class 1. (Class 1 is the highest drop height and impact energy class in that standard).

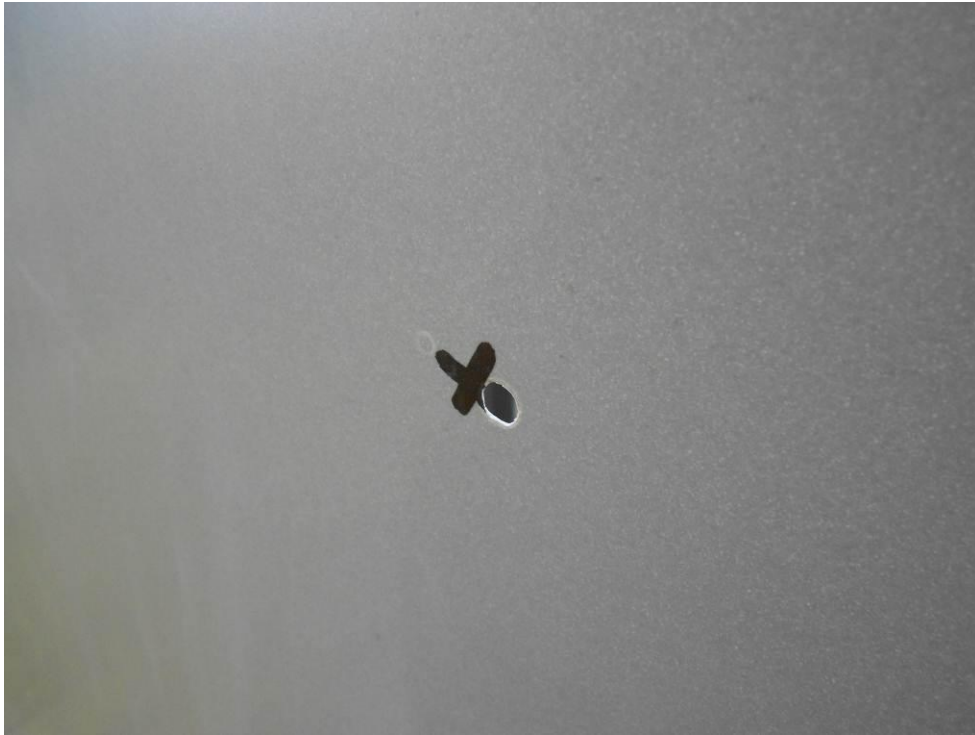
Figure 11. Typical damage after hard body impact on 20 mm thick panels – damage on the front face corresponding to Figure 12 below.

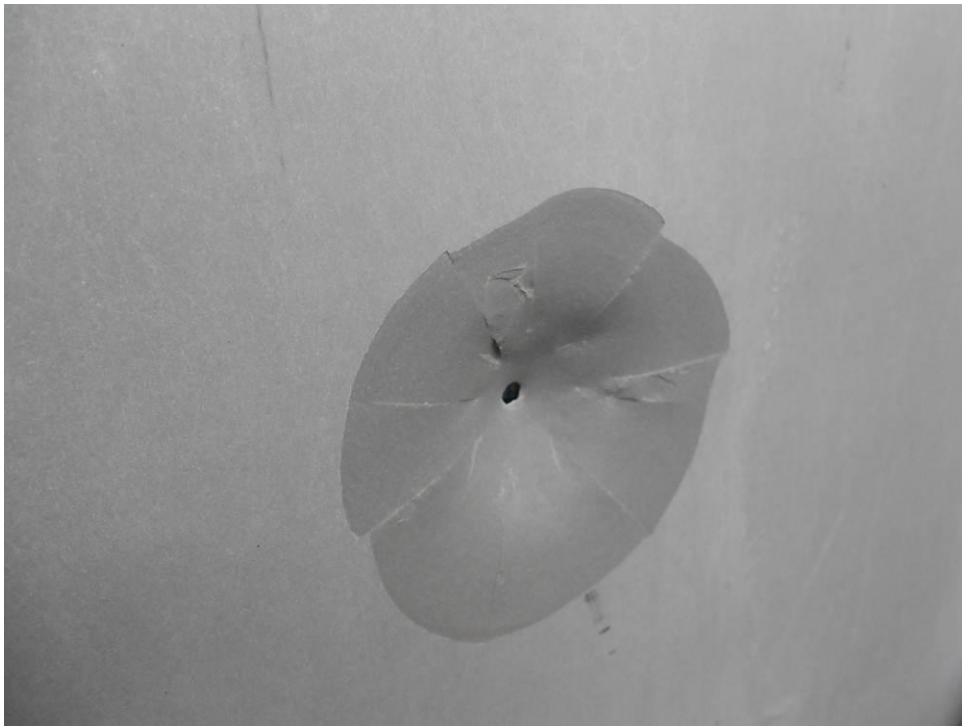
Figure 12. Typical damage after hard body impact on 20 mm thick panels – on the reverse side of the panel.

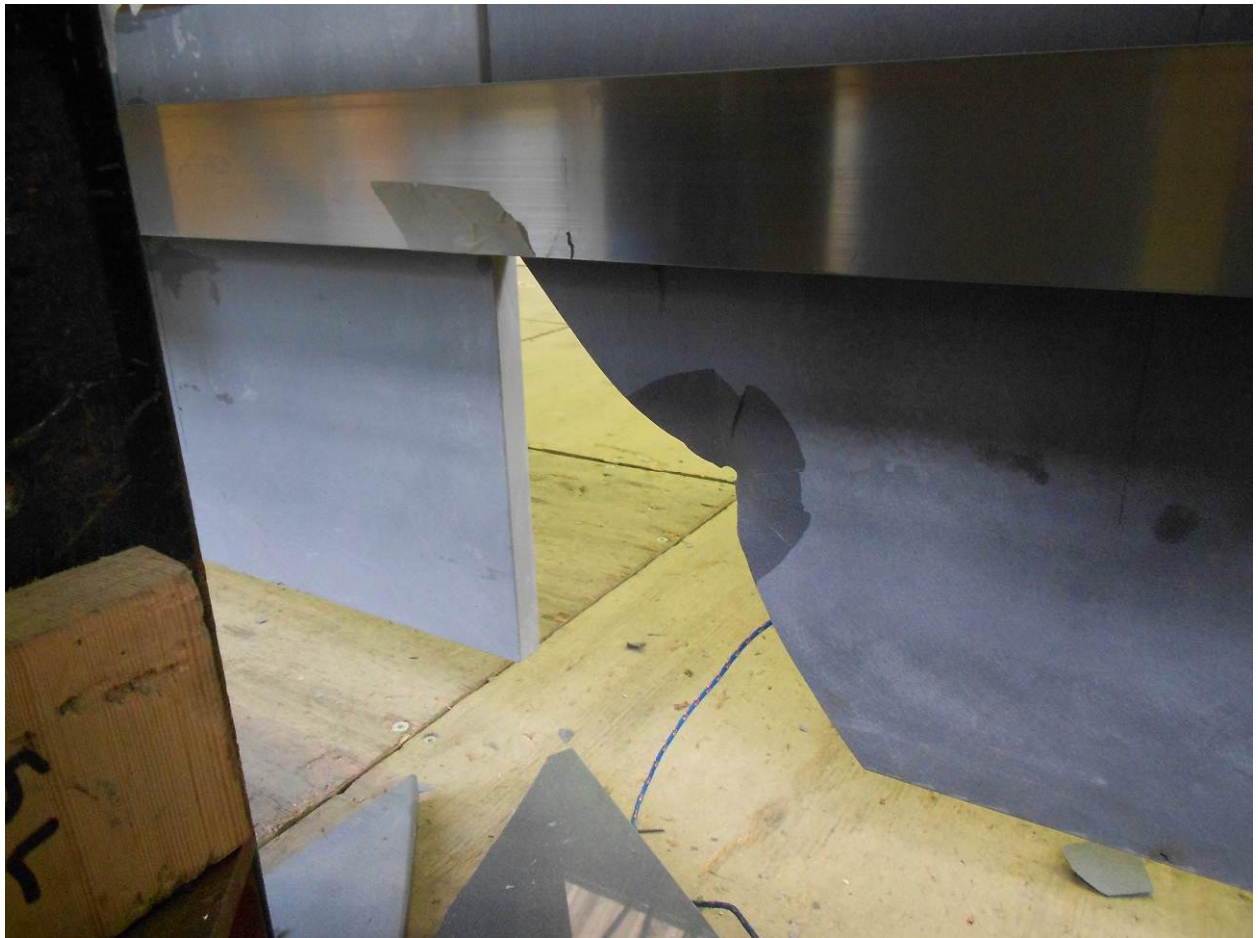
Figure 13. Typical damage after hard body impact on 20 mm thick panels – near a corner of the panel.

20 mm thick panels: When subjected to 3.0 Nm impact near a corner of a panel a large section broke away on impact. In BS 8200, for brittle materials, the results of the impact tests are defined as either failure or no damage. (see Section 3 of this report, Assessment criteria).

The 20 mm thick Lapitec stone panel wall system fails when subjected to hard body impacts at the lowest impact energy (3 Nm) given in BS 8200 for retention of performance of exterior wall surfaces.

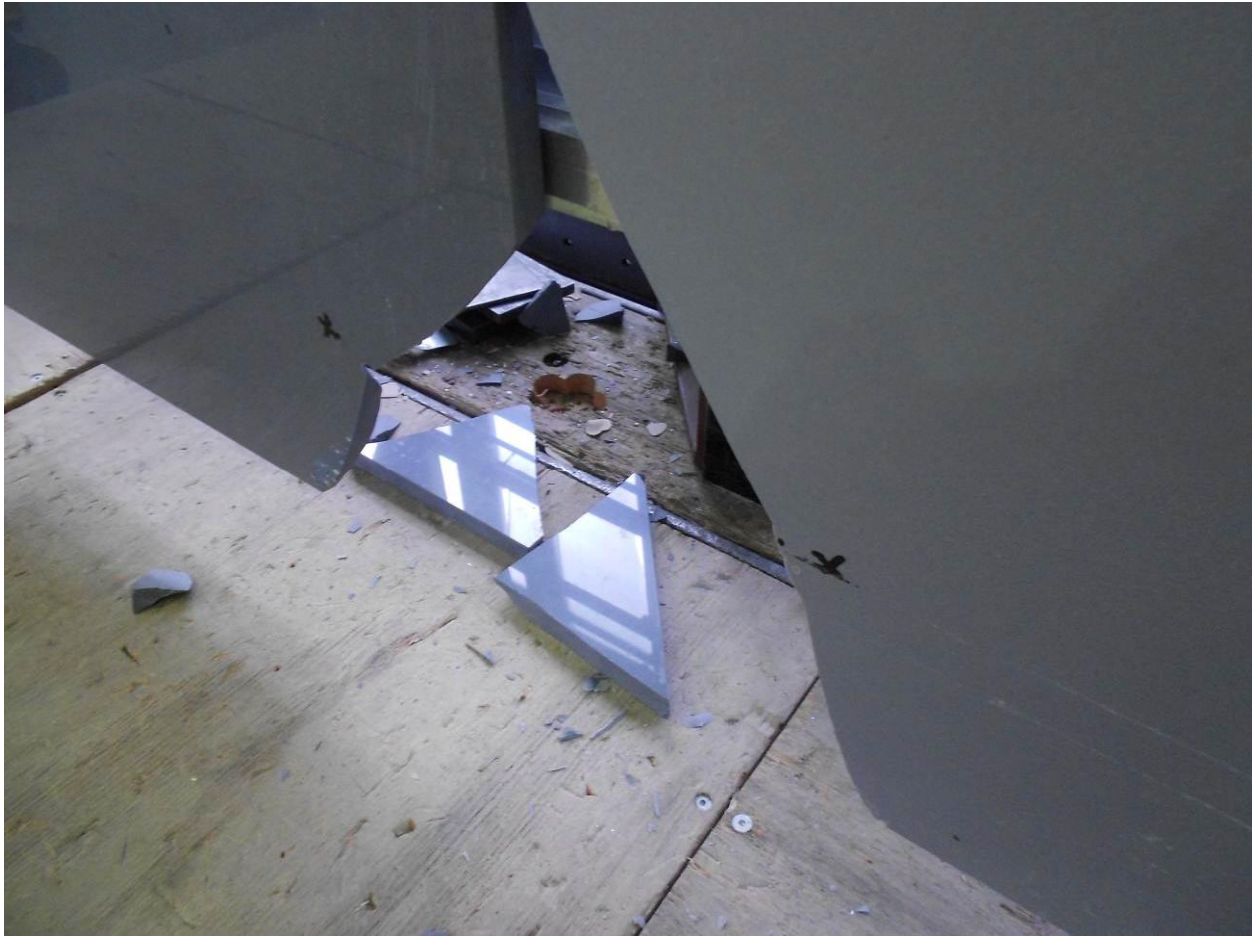
Figure 14. Typical damage after hard body impact on 20 mm thick panels – near to corners of the panels.

There is no requirement in BS8298:2010 for high body impacts but reference to the now withdrawn BS8200:1985 shows that the performance of the 20mm panels is acceptable for ensuring the safety of persons but not for retention of performance. The panels are particularly vulnerable at the corners.

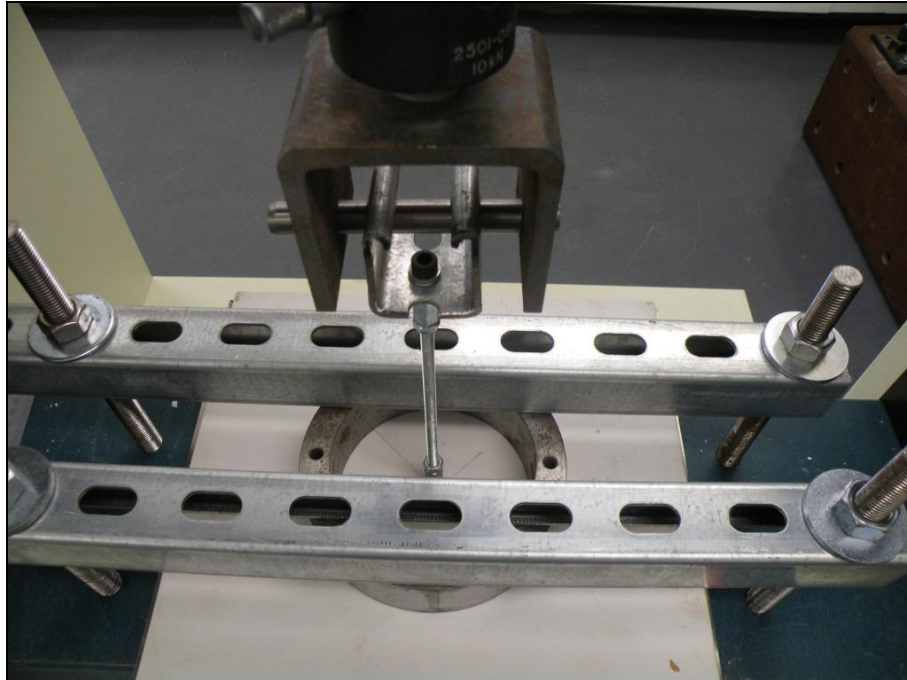
Figure 15: Showing test set up with 110 mm diameter ring

Two reaction rings (Figures 15 and 16 show the test set ups) were used during the testing:

The first ring had an internal diameter of 110 mm (however this was found to be adding restraint to the anchor point, see Figure 17) and was replaced with a larger ring of 270 mm internal diameter.

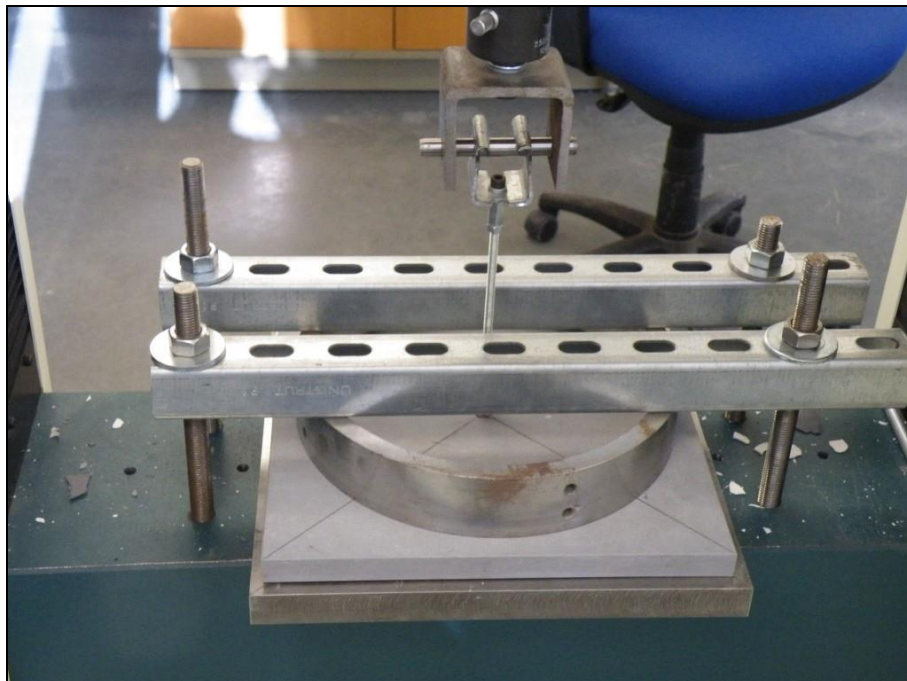
Figure 16: Showing test set up with 270 mm diameter ring

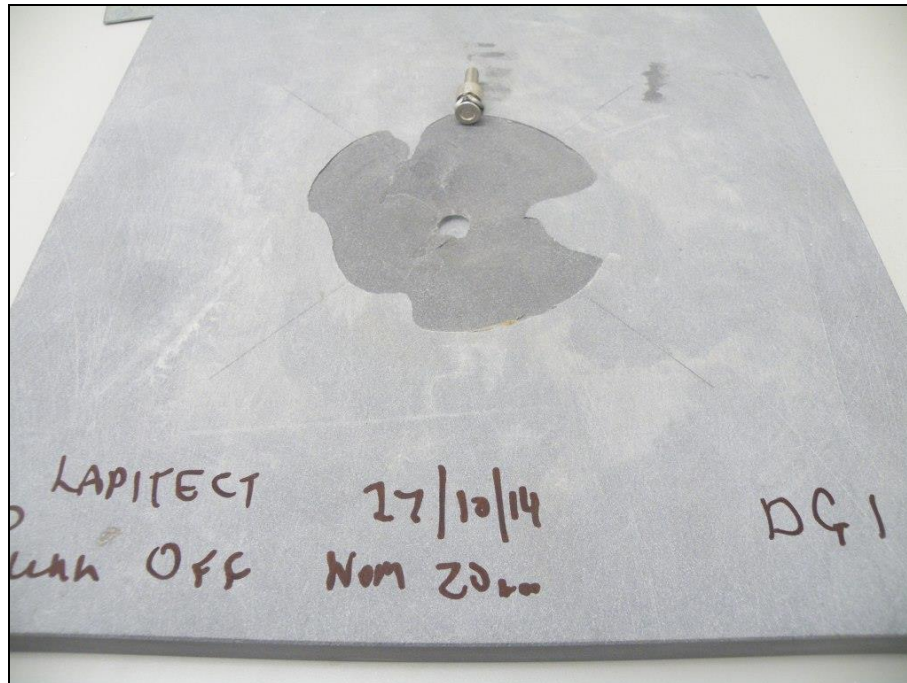
Figure 17: Showing failure on 20 mm thick panel (DG1) with 110 mm ring note the curved shape of the break were the ring was adding additional restraint.

The results from the anchorage tests showed that the method of securing the test specimens had a significant effect on the results. Use of a smaller retention ring (110mm) resulted in a 'cone' failure and higher results than the larger ring (270mm) where failure was due to cracking of the specimen.

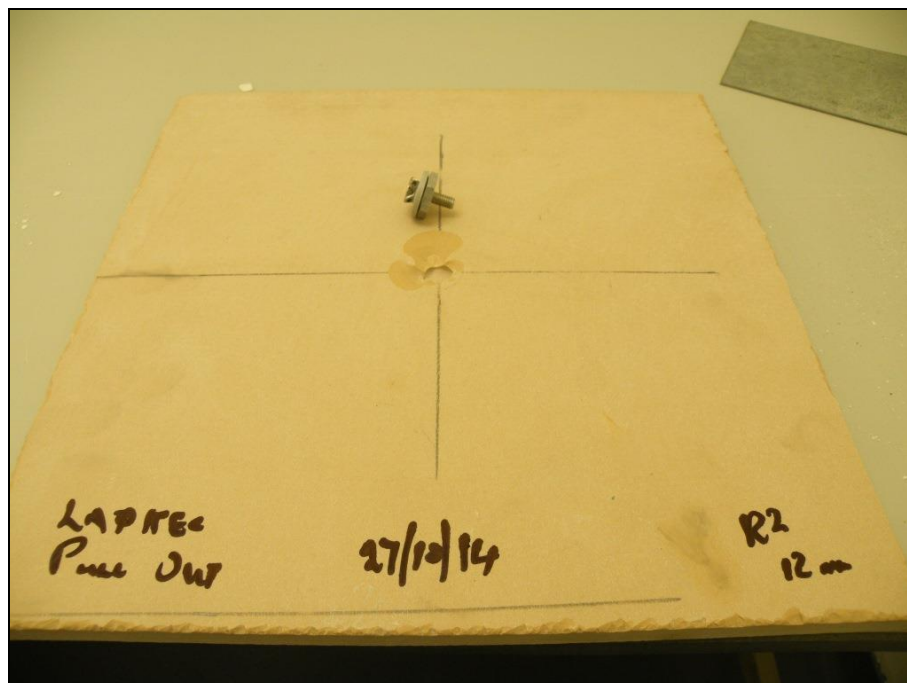
Figure 18: Showing failure on 12 mm thick panel (R2) with 110 mm ring note the no additional restraint was provided by the restraint ring.

Figures 18 and 19 show the typical failures.

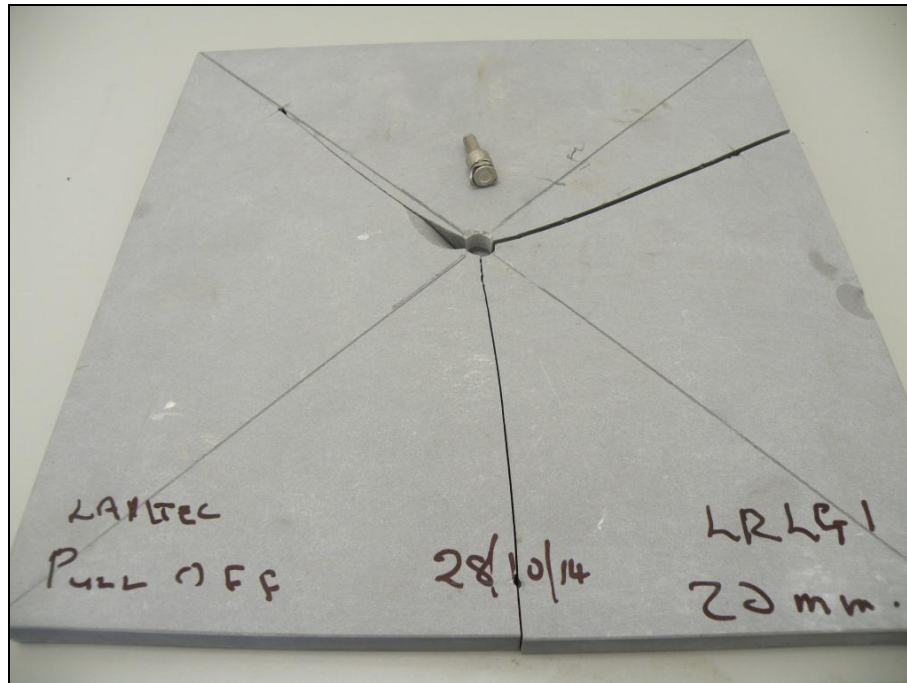
Figure 19: Showing failure on 20 mm thick panel (LRLG1) with 270 mm diameter ring specimen broke into 3 pieces.
