Corian® Exteriors Lights up the Yerkes Guard House

Corian® Exteriors by DuPont is used throughout the world to bring personality to virtually any type of environment. A new guard house in front of the Buffalo Yerkes plant, where most Corian® Solid Surface is manufactured, used Corian® Exteriors to help achieve a unique looking design. The panels on the building are Corian® Solid Surface Glacier White and the outer barrier walls with backlight panels are Corian® Solid Surface Cameo White. Backlight panels on the guard house also expand what has been done with panels and mounting in an exterior application.

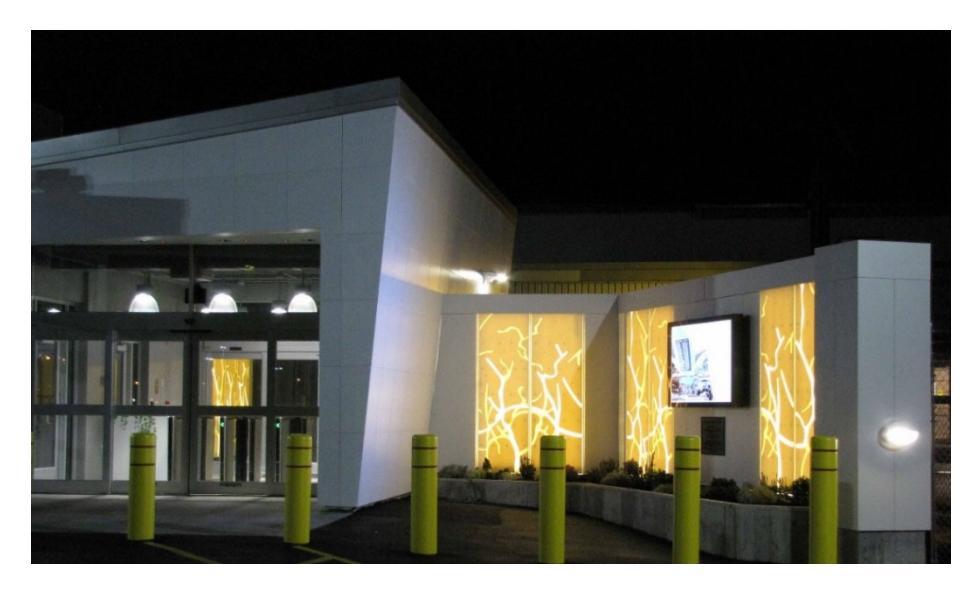
Figure 1: Yerkes Guard House; Entrance Hall and Front Video Screen Wall. Includes a view of the guard house entrance hall, west wall, and video screen wall. The backlight garden wall on the inner side of the entrance hall is also visible.

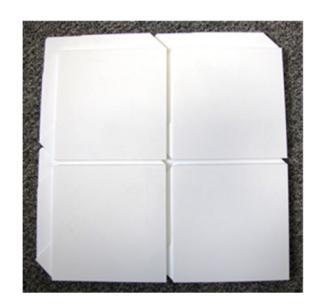
One of the unique features of the Guard House is the multi-level ship lap on the cladding panel edges. This ship-lap, or over-lap detail provides an effective joint closure design while still allowing for proper expansion and contraction of the building components. The performance-through nature of Corian® Solid Surface allows for this type of routing, without compromising the durability of the material at the cut areas and eliminates visibility through joints in the drained and back ventilated rainscreen system.

Figure 2: Over-lap joints create a continuous look and eliminate visibility between panels.

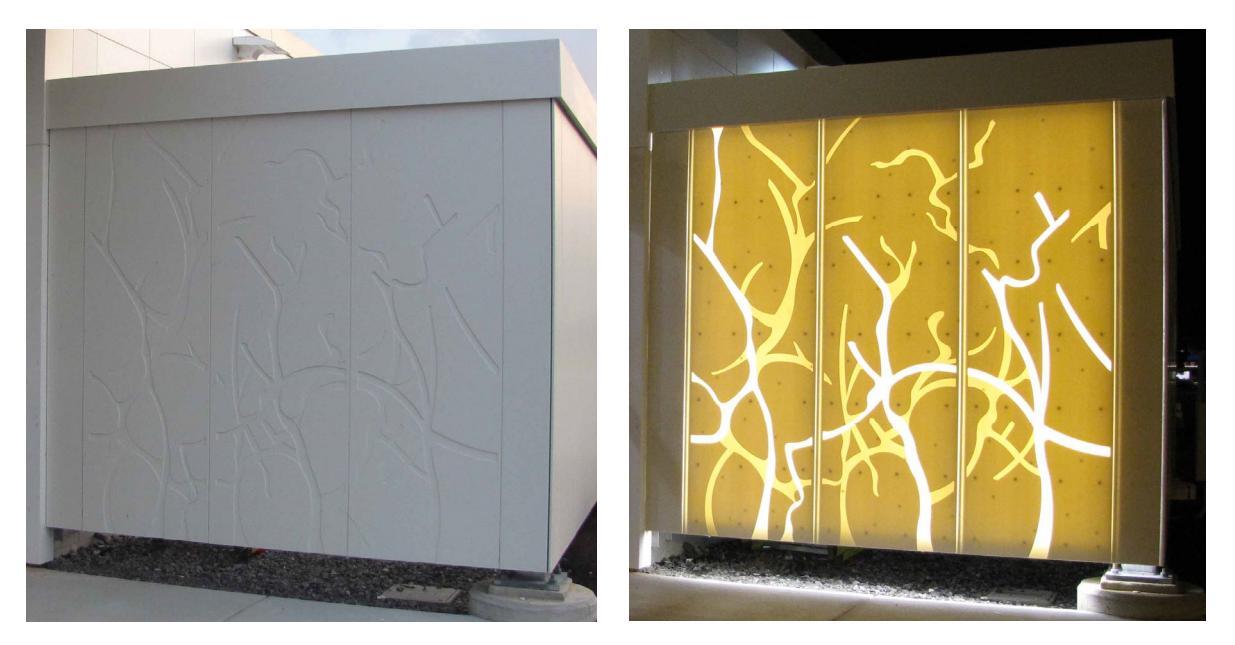
The backlight panels vary according to the darker regions which are thicker in size than the lighter branch areas. The thinner sections were included in this design to achieve the backlight color contrasts and was accommodated by using much smaller fastener spacings to achieve needed wind load structural performance. The black dots are connectors in the back surface of the panels. Random dots, created with tape, were added to make the linear connector pattern less obvious.

Figure 3: Day and Night Photos of the Garden Wall Backlight.

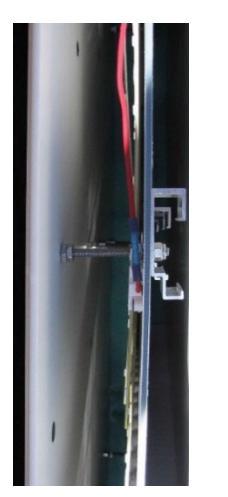
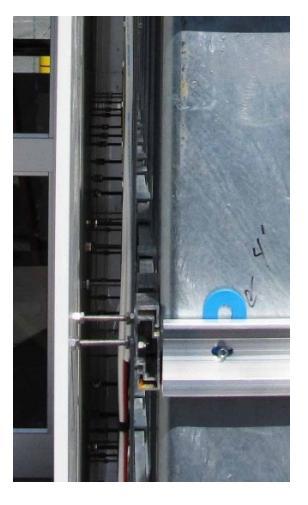
A challenge for backlight applications is creating the required fixation back to structure without creating substructure rail shadows in the backlight aesthetic. For exterior, the substructure system also needs to include large movement capability to accommodate panel expansion and contraction with temperature changes. A new mounting approach was incorporated on the guard house. Threaded studs are mounted into inserts in the back surface of the Corian[®]. The opposite end of these studs is mounted on extruded clasps of a conventional clasp/rail rain screen system. The clasp/rail system allows the needed solid surface movement.

Figure 4: Side view images of the mounting system of a backlighted panel before install and panels mounted on the garden wall.
